The Overlook Land Owners Association
Evergreen, CO

Report #: 57381-0
Beginning: January 1, 2026
Expires: December 31, 2026

RESERVE STUDY
"Full"

Site Inspection Notes

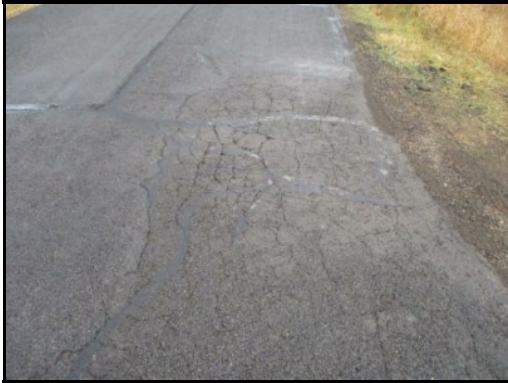
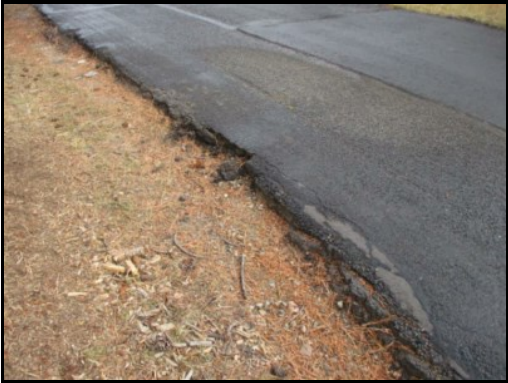
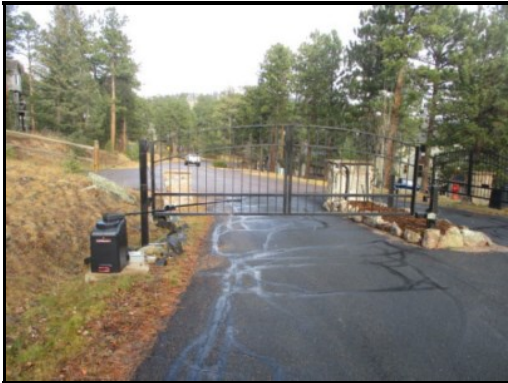
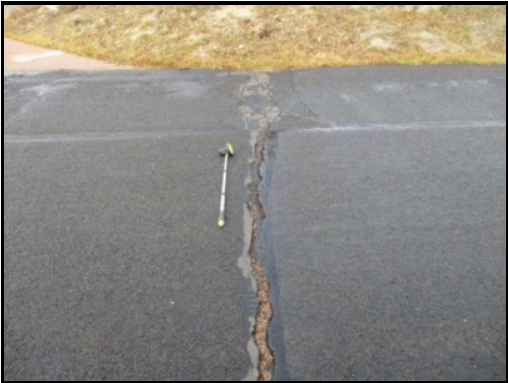
During our site visit on 11/21/2025 we visually inspected the common area assets and were able to see a majority of the common areas. Please see photo appendix for component details; the basis of our assumptions.

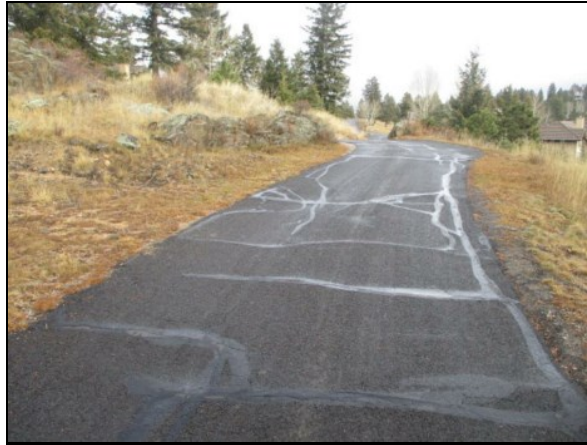
Comp #: 21190 Asphalt - Seal/Repair

Comments: Asphalt seal was observed to be in fair condition with no major issues noted at the time of the inspection. Regular cycles of seal coating (along with any needed repair) has proven to be the best program in our opinion for the long term care of lower traffic asphalt areas such as these. The primary reason to seal coat asphalt pavement is to protect the pavement from the deteriorating effects of sun and water. When asphalt pavement is exposed the asphalt oxidizes or hardens which causes the pavement to become more brittle. As a result the pavement will be more likely to crack because it is unable to bend and flex when subjected to traffic and temperature changes. A seal coat combats this situation by providing a waterproof membrane which not only slows down the oxidation process but also helps the pavement to shed water preventing it from entering the base material. Seal coat also provides uniform appearance concealing the inevitable patching and repairs which accumulate over time. Seal coat ultimately extends useful life of asphalt postponing the asphalt resurfacing which can be one of the larger cost items in this study (see component #21200 for asphalt resurfacing costs). Repair asphalt before seal coating. Surface preparation and dry weather during and following application is key to lasting performance. The ideal conditions are a warm sunny day with low humidity. Rain can cause major problems when seal coating and should never be done when showers are threatening. Incorporate any striping and curb repair into this project. Fill cracks and clean oil stains promptly in between cycles as routine maintenance. Prior to a seal coat application the areas will be cleaned with push blowers and wire brooms. Be aware that sealcoat will not adhere to heavily saturated oil spots. Vendors typically recommend infrared patching on areas with saturated oil spots to ensure adherence of sealcoat.

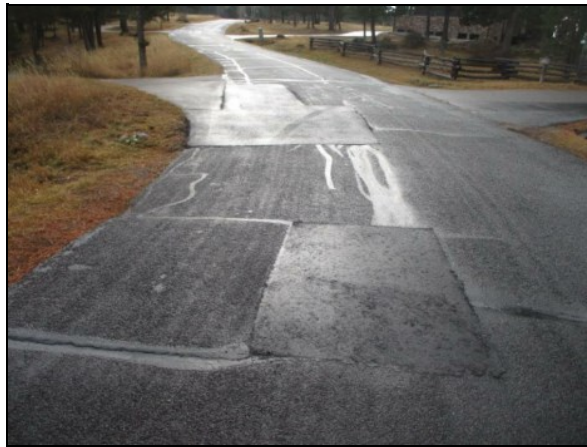
Comments: Includes approximately (20,785 GSF) Overlook Trail (entrance to first roundabout), (22,157 GSF) Overlook Trail (West Fork), (26,556 GSF) Spring Valley Trail (Middle Fork), and (28,794 GSF) Mountainside Trail (East Fork). It was reported there is an estimated 3-5 years left. Asphalt pavement determined to be in fair condition typically exhibits a mostly uniform surface but with minor to moderate raveling and surface wear. If present crack patterns are normal for the age of the asphalt and not extreme and there are no signs of advanced deterioration such as large block cracking patterns "alligating" or potholes. Overall appears to be aging normally and still up to an appropriate aesthetic standard. Useful life below assumes regular seal coating and repairs. The lack of seal coating and repairs can greatly decrease the asphalt's useful life. Resurfacing is typically one of the larger expense items in a Reserve Study. When need to resurface is apparent within a couple of years consult with geotechnical engineer for recommendations specifications / scope of work and project oversight. As routine maintenance keep surfaces clean and free of debris ensure that drains are free flowing repair cracks and clean oil stains promptly. Assuming proactive maintenance plan to resurface at roughly the time frame below. If regular maintenance and sealing is deferred client may need more extensive repair and replacement projects. Funding below assumes that asphalt has adequate subgrade as well as asphalt fill depth. If fill depth is less than 2" client may need to consider a remove and replacement project which can increase costs by 50% or more. Further resources: Pavement Surface Condition Field Rating Manual for Asphalt Pavement. <https://www.co-asphalt.com/maintenance-and-preservation>

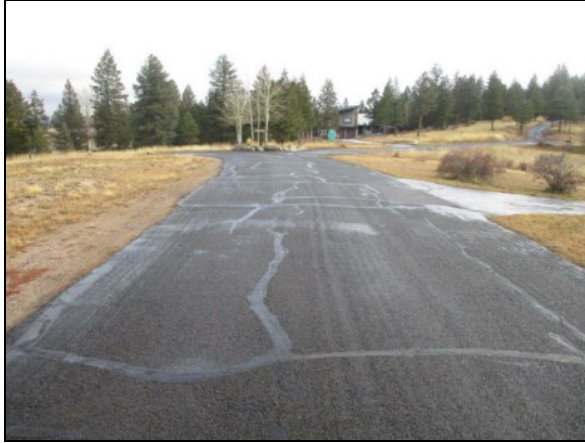
Comp #: 21210 Asphalt - Crack Fill/Repair

Comments: Minor cracking or separation observed at the time of our inspection. This line item allows the client to budget for predictable crack fill and sealing on a periodic basis.

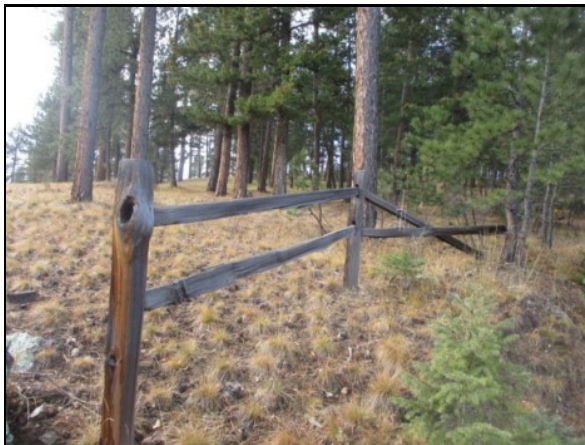
Comp #: 21340 Site Fencing: Wood Rail - Replace

Comments: As routine maintenance inspect regularly for any damage repair as needed and avoid contact with ground and surrounding vegetation wherever possible. Regular cycles of uniform professional sealing/painting will help to maintain appearance and maximize life. In general costs related to this component are expected to be included in the client's Operating budget. No recommendation for Reserve funding at this time. However any repair and maintenance or other related expenditures should be tracked and this component should be re-evaluated during future Reserve Study updates based on most recent information and data available at that time. If deemed appropriate for Reserve funding component can be included in the funding plan at that time.

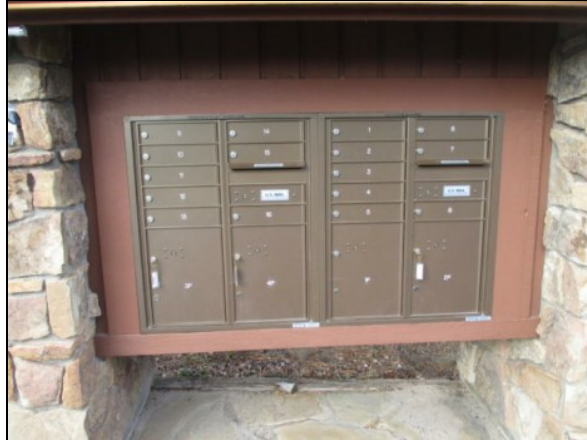
Comp #: 21600 Mailbox Kiosks - Replace

Comments: Includes approximately (32) mail slots and (8) parcel boxes. Mailbox kiosks determined to be in good condition typically exhibit a uniform appearance without much surface wear. Hardware appears to be in good condition and boxes/panels appear to close and lock properly. Appearance and style are consistent with the aesthetic standards of the development. Inspect regularly and clean by wiping down exterior surfaces. If necessary change lock cylinders lubricate hinges and repair as an Operating expense. Best to plan for total replacement at roughly the time frame below due to constant exposure usage and wear over time. Note USPS has a limited budget for replacement and should not be relied upon for purposes of long term planning.

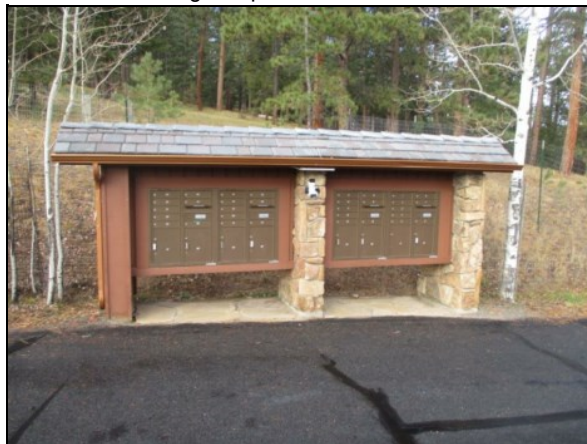
Comments: Includes (1) 18'x4' structure of wood and stone, plastic shingles, 18' gutters, and 10' downspouts. Inspect regularly. At this time costs related to this component are expected to be included in the client's Operating budget. No recommendation for Reserve funding at this time. However any repair and maintenance or other related expenditures should be tracked and this component should be re-evaluated during future Reserve Study updates based on most recent information and data available at that time. If deemed appropriate for Reserve funding component can be included in the funding plan at that time.

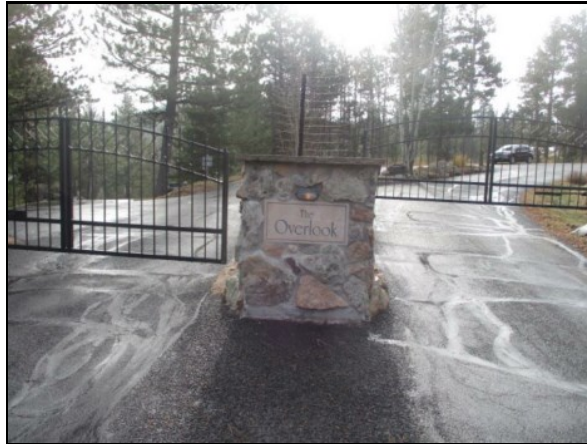
Comments: Includes (1) 4'x4.5' high stone monument with light and (2) 3'x3.5' high stone monuments. Monument signage determined to be in fair condition typically exhibits acceptable appearance and aesthetics in keeping with local area but with more weathering and wear showing on surfaces. If present landscaping and lighting are still in serviceable condition. At this stage signage may be becoming more dated and diminishing in appeal. As routine maintenance inspect regularly clean/touch-up and repair as an Operating expense. Plan to refurbish or replace at the interval below. Timing and scope of refurbishing or replacement projects is subjective but should always be scheduled in order to maintain good curb appeal. In our experience most clients choose to refurbish or replace signage periodically in order to maintain good appearance and aesthetics in keeping with local area often before signage is in poor physical condition. If present concrete walls are expected to be painted and repaired as part of refurbishing but not fully replaced unless otherwise noted. Costs can vary significantly depending on style/type desired and may include additional costs for design work landscaping lighting water features etc. Reserve Study updates should incorporate any estimates or information collected regarding potential projects.

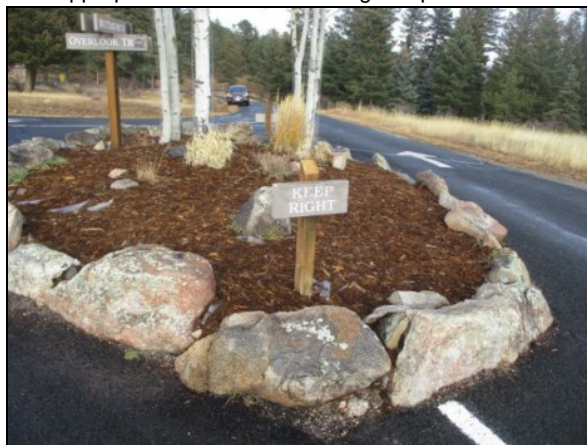
Comp #: 21640 Informational Signs - Replace

Comments: Includes approximately (17) Misc. Street and Traffic Signs, and (30) Home Address Signs. Maintain repair and replace as needed as an Operating expense. However any repair and maintenance or other related expenditures should be tracked and this component should be re-evaluated during future Reserve Study updates based on most recent information and data available at that time. If deemed appropriate for Reserve funding component can be included in the funding plan at that time.

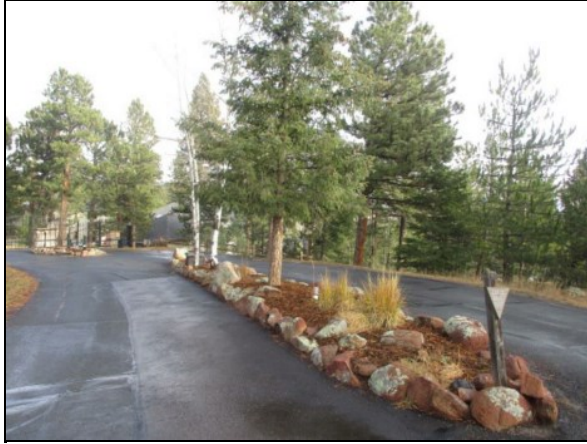
Comments: In general costs related to this component are expected to be included in the client's Operating budget. No recommendation for Reserve funding at this time. However any repair and maintenance or other related expenditures should be tracked and this component should be re-evaluated during future Reserve Study updates based on most recent information and data available at that time. If deemed appropriate for Reserve funding component can be included in the funding plan at that time.

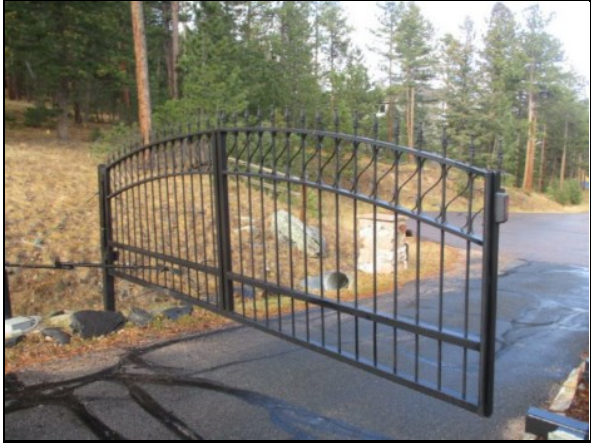
Comp #: 21380 Entry Gates - Replace

Comments: Gate(s) determined to be in fair condition typically exhibit minor to moderate corrosion or rust hardware may show some wear and corrosion but gate(s) operate properly and connections and supports appear to be secure. It was reported that the gates were recently repaired. Fair appearance overall. We strongly recommend regular inspections maintenance and repairs to help extend useful life cycles. Clean for appearance and paint/touch-up as needed within general maintenance/Operating funds. Although metal gates are typically durable we recommend setting aside funding for regular intervals of replacement due to constant wear/usage exposure and vehicle damage. Replacement can also be warranted for aesthetic changes over time. Plan to replace at roughly the time frame shown below.

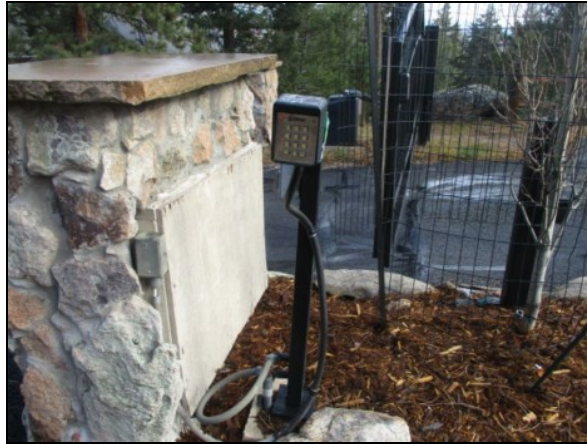
Comp #: 25010 Push Button Entry System - Replace

Comments: Access/intercom system was not inspected internally during site inspection. Should be checked and repaired as needed by servicing vendor as routine maintenance. Individual components can often be replaced for relatively low cost as an Operating expense. Plan for complete replacement at the approximate interval shown here for functional and aesthetic considerations.

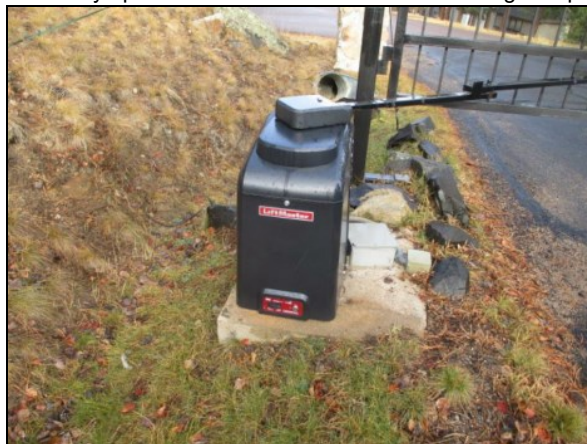
Comp #: 25060 Entrance Gate Operator – Replace

Comments: Includes (1) Entrance Gate, Lift Master, M/N CSW24UL, 02/04/25. The cover was replaced in 2025 due to damage, but the operator was not fully replaced. Minimal or no subjective/aesthetic value for this component. Useful life is based primarily on normal expectations for service/performance life in this location. Unless otherwise noted remaining useful life expectancy is based primarily on original installation or last replacement/purchase date our experience with similar systems/components and assuming normal amount of usage and good preventive maintenance. We recommend regular inspections (including service and repair as needed) be paid through the Operating budget. Even with ongoing maintenance plan for replacement at typical life expectancy indicated below. Useful life can vary greatly depending on level of use exposure to the elements etc. Monitor actual expenses closely for future Reserve Study updates. Unless otherwise noted funding to replace with similar units.

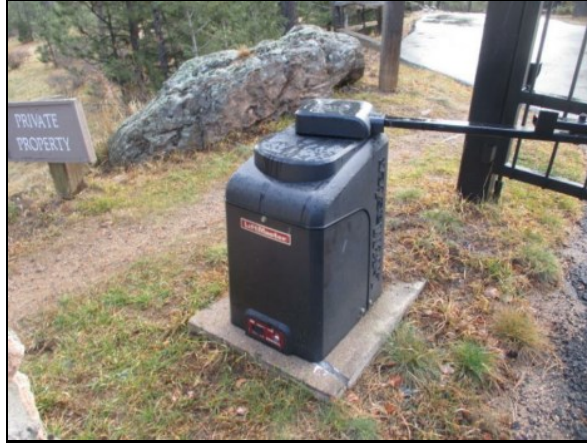
Comp #: 25060 Exit Gate Operator – Replace

Comments: Includes (1) Exit Gate, Lift Master, M/N CSW24UL, S/N 2419N7818, 06/13/19. Minimal or no subjective/aesthetic value for this component. Useful life is based primarily on normal expectations for service/performance life in this location. Unless otherwise noted remaining useful life expectancy is based primarily on original installation or last replacement/purchase date our experience with similar systems/components and assuming normal amount of usage and good preventive maintenance. We recommend regular inspections (including service and repair as needed) be paid through the Operating budget. Even with ongoing maintenance plan for replacement at typical life expectancy indicated below. Useful life can vary greatly depending on level of use exposure to the elements etc. Monitor actual expenses closely for future Reserve Study updates. Unless otherwise noted funding to replace with similar units.

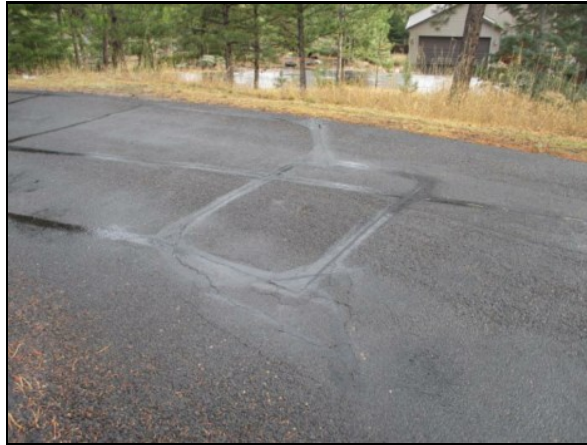
Comp #: 25090 Loop Detectors – Replace

Comments: Minimal or no subjective/aesthetic value for this component. Useful life is based primarily on normal expectations for service/performance life in this location. Unless otherwise noted remaining useful life expectancy is based primarily on original installation or last replacement/purchase date our experience with similar systems/components and assuming normal amount of usage and good preventive maintenance. Loop detectors are wires under the asphalt or concrete (usually a rectangular pattern in asphalt) and are used to detect vehicles passing over the area which in turn signals the gate operator to open or close once the vehicle has passed. Wires are susceptible to moisture penetration through asphalt/concrete. Cycle replacing this component with asphalt/concrete work.
